**DEPARTMENT OF TRANSPORTATION****DIVISION OF ENGINEERING SERVICES**

Contract #: 04-0120F4Cty: SF/ALA Rte: 80 PM: 13.2/13.9File #: 13.28**WELDING INSPECTION REPORT****Resident Engineer:**Pursell, Gary**Address:** 333 Burma Road**City:** Oakland, CA 94607**Report No:** WIR-009554**Date Inspected:** 12-Oct-2009**Project Name:** SAS Superstructure**OSM Arrival Time:** 700**Prime Contractor:** American Bridge/Fluor Enterprises, a JV**OSM Departure Time:** 1530**Contractor:** Oregon Iron Works Clackamas, Or.**Location:** Clackamas, OR**CWI Name:** Mike Gregson, Jose Salazar**CWI Present:** Yes No**Inspected CWI report:** Yes No N/A**Rod Oven in Use:** Yes No N/A**Electrode to specification:** Yes No N/A**Weld Procedures Followed:** Yes No N/A**Qualified Welders:** Yes No N/A**Verified Joint Fit-up:** Yes No N/A**Approved Drawings:** Yes No N/A**Approved WPS:** Yes No N/A**Delayed / Cancelled:** Yes No N/A**Bridge No:** 34-0006**Component:** Hinge K Pipe Beams**Summary of Items Observed:**

**OIW Fabrication Shop-Bay 3****Hinge-K Pipe Beam Assembly 102A-1: 10/12/09****a111-1 Forging to a110-1 Base Plate**

**Hinge-K Pipe Beam Fuse Assembly 120A-3: 10/12/09****a124-12 Half Fuse to a124-1

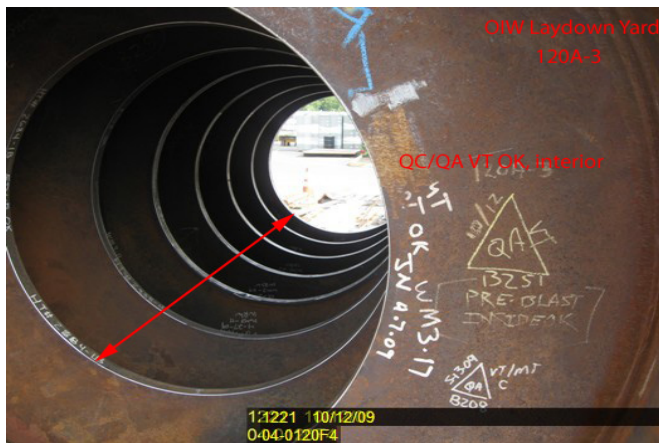
QA Inspector spoke with QC Inspector Jose Salazar and Mr. Salazar explained that welder #F17, Mr. Igor Frolov, was currently in-process, of performing the weld clean-up and grinding, on the previously marked interior of fuse

QA Inspector noted that this fuse assembly 120A-3, would be transferred to OIW Vancouver, WA. painting facility and the interior blasted at a later date and an OIW QC Inspector and QA Inspector will then perform an after blast visual inspection, per AWS D1.5 and contract requirements, prior to OIW applying inorganic zinc primer coat. See attached picture below.
